PHOTOGRAPHS  
WRITTEN HISTORICAL AND DESCRIPTIVE DATA

GOVERNORS ISLAND, BUILDING #2

HABS No. NY-5715-4

Present Use: Residence of the Commanding Officer, United States Coast Guard, Support Center, New York

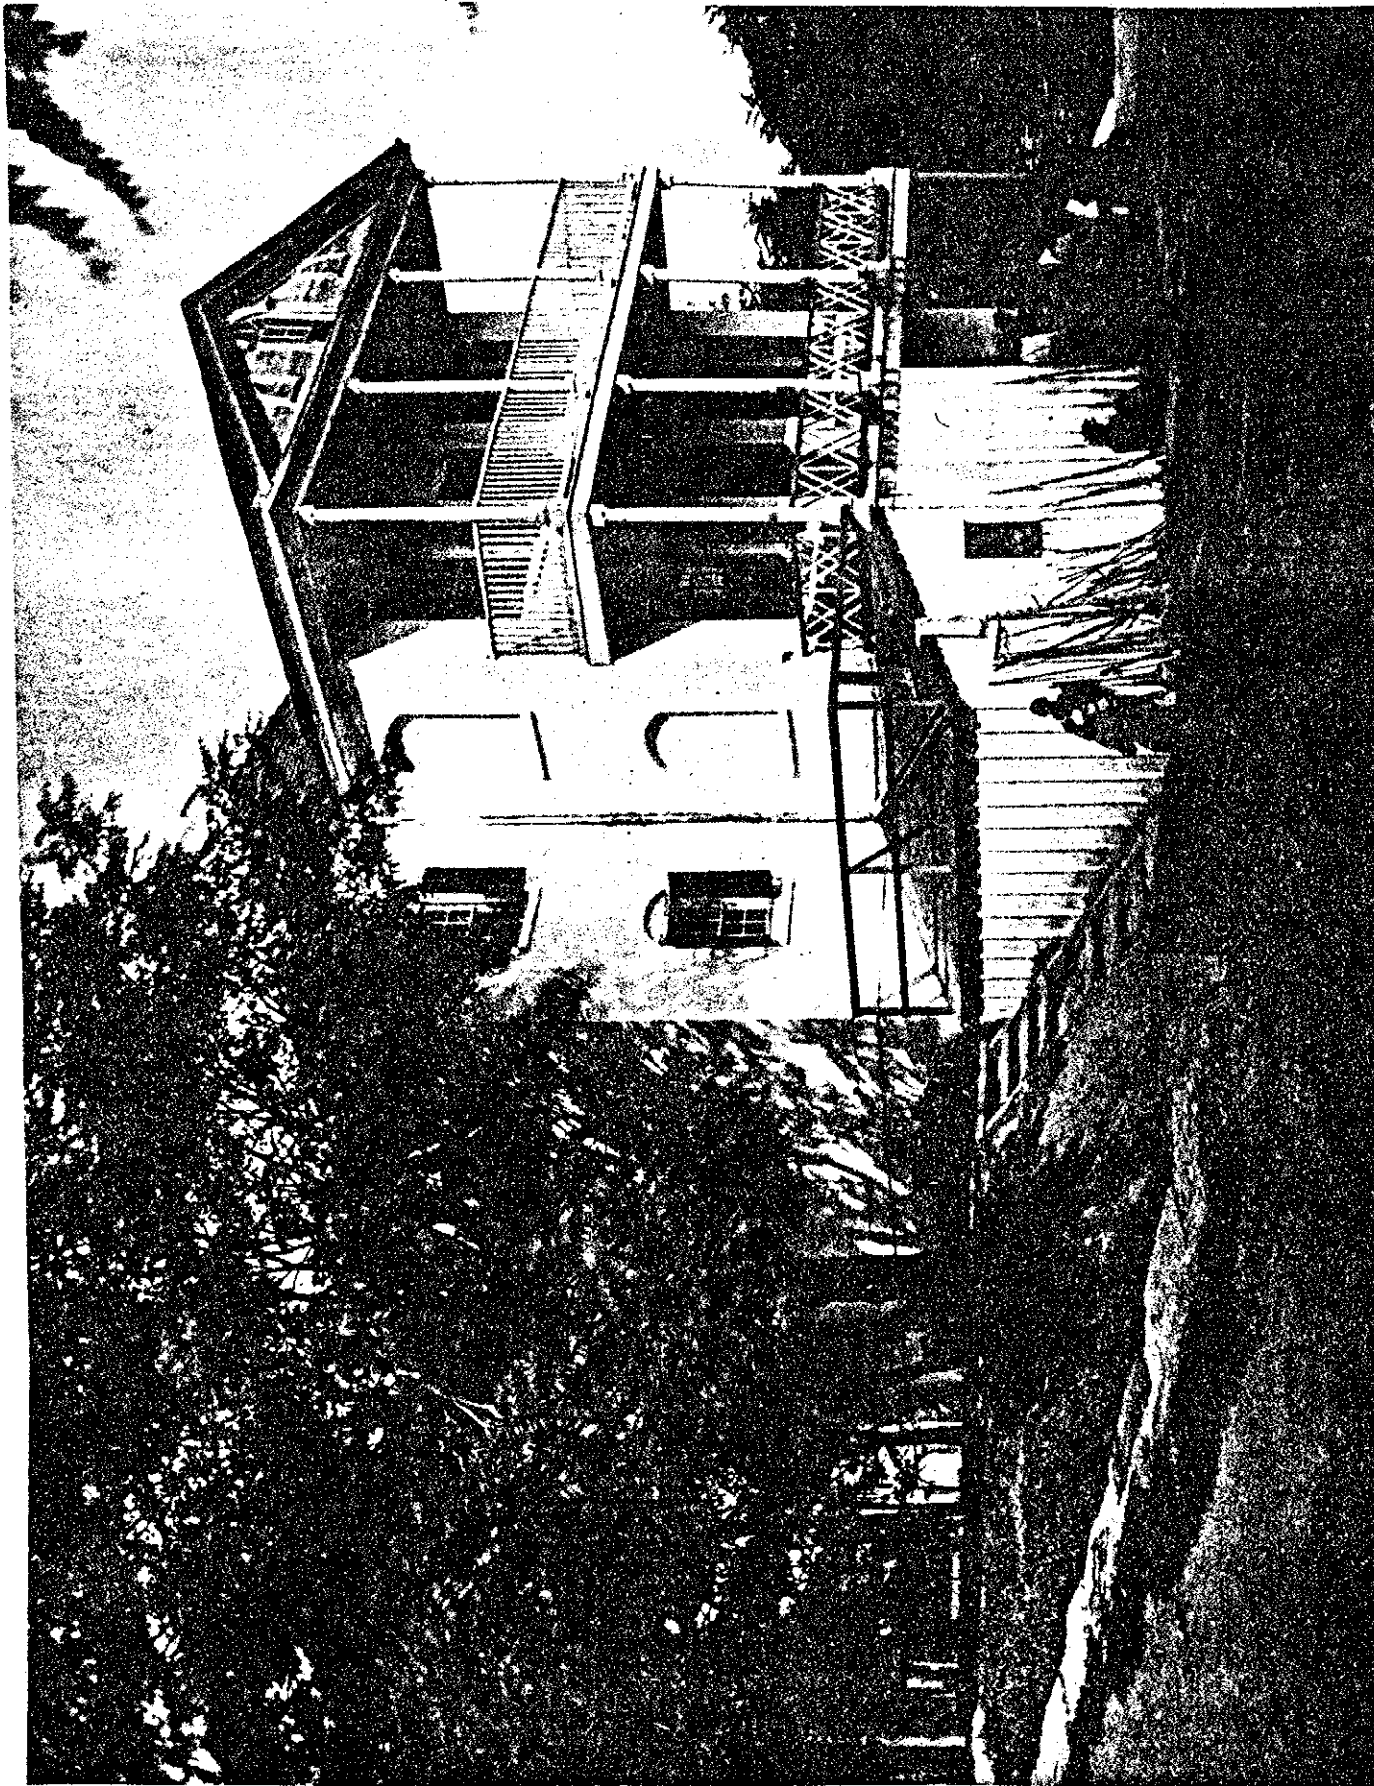
Plate 4  
Reproduction of Photograph of Quarters 2  
National Archives, Still Pictures Branch  
Record Group 165-C-1090  
North Side  
Photographer unknown, 1864

A drawing made in December 1839 (Plate 3) shows changes in the building's exterior since Mangin's 1813 plan and cross section of the Island. The roof had been changed to a combination hipped and gable roof, and the portico on the east side had been altered. By that time, the two story portico had been removed and replaced with one-story porches on each floor. A one-story rectangular addition had also been built at the southwest corner of the building. The addition with horizontal wood siding is shown in an 1864 photograph (Plate 4). These may have been among the changes made in the 1824 conversion.
